Manhole Inspection Summary

Manhole # S41A1_005MH

Insp Date: **12/18/08 10:10 AM**

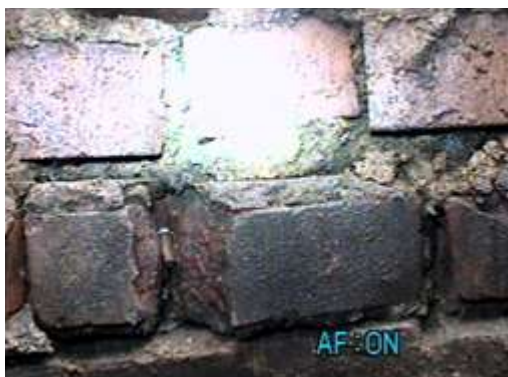
Defect 2

Corbel Material: **Brick** ☐ Parged Type: **Concentric/Eccentric**
Condition: ☐ Sound ☐ Cracked ☐ Root Intrusion ☒ **Loose Brick** ☐ Deteriorated
Infiltration: ☒ None ☐ Joint ☐ Cracks ☐ Mortar ☐ Roots ☐ Wall

corbel loose bricks

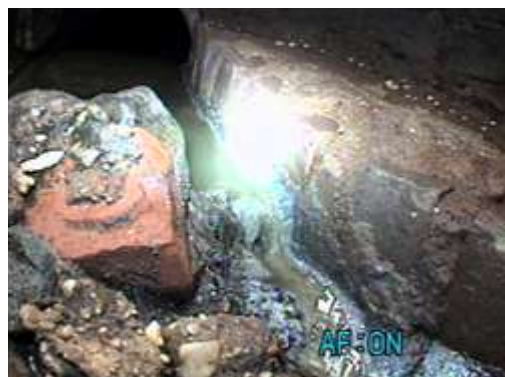
Defect 3

Channel Material: **Brick** ☐ Parged
Channel Exposure: **Partially Open** Junc Dist: **0** nearest .5 ft. Azimuth: **0**
Condition: ☐ Sound ☐ Cracked ☐ Root Intrusion ☐ Deteriorated ☐ Leaks ☒ **Debris**

channel debris

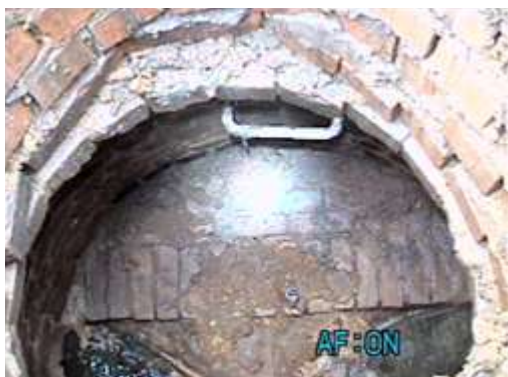
Defect 1

Steps Count: **1** Missing: **0** ☒ **Corroded**

step corroded

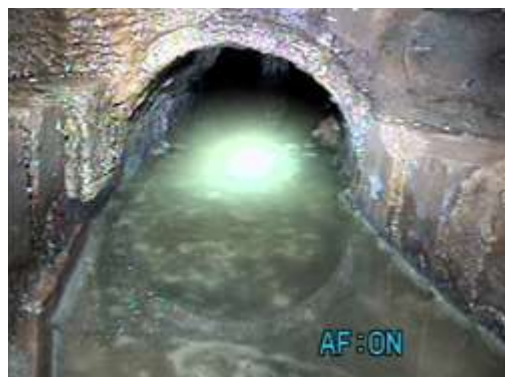
Defect 4

Barrel Material: **Brick** ☐ Parged
Shape: **Circular** Diameter: **48** (in.) Length: **0** (in.)
Condition: ☒ Sound ☐ Cracked ☐ Root Intrusion ☐ Loose Brick ☐ Deteriorated
Infiltration: ☐ None ☐ Joint ☐ Cracks ☐ Mortar ☐ Roots ☒ **Wall**

Barrel infiltration

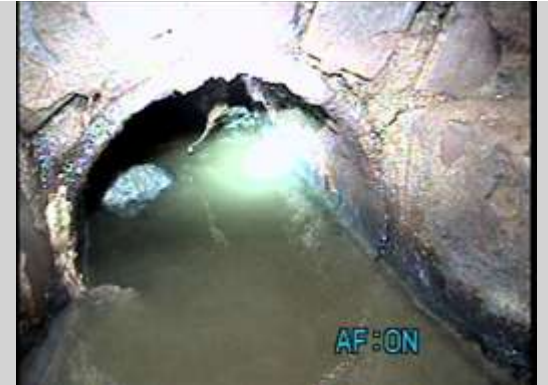
12 O'Clock Outflow

10 in. Circular Gravity Sewer
Pipe Out @ 12 O'Clock

Invert Depth: **6.16** (ft.) Flow Characteristics: **Slow**

Infiltration: **None** Pipe Seal Cond: **Unknown**

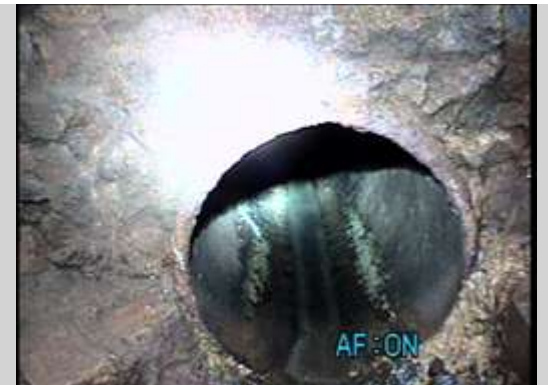
3 O'Clock Inflow

10 in. Circular Gravity Sewer
Pipe In @ 3 O'Clock

Invert Depth: **5.58** (ft.) Flow Characteristics: **None**

Infiltration: **None** Pipe Seal Cond: **Unknown**

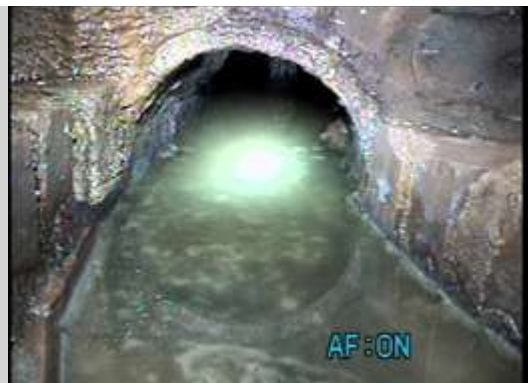
9 O'Clock Inflow

8 in. Circular Gravity Sewer

Pipe In @ 9 O'Clock

Invert Depth: **5.75** (ft.) Flow Characteristics: **Slow**

Infiltration: **None** Pipe Seal Cond: **Unknown**
